*Pennine Prospects  
Celebrating Our Woodland Heritage Project  
Report No: PP27/270319*

# **Celebrating Our Woodland Heritage Redisher Wood, Holcombe: An Archaeological Woodland Survey**

Report No: PP27/270319

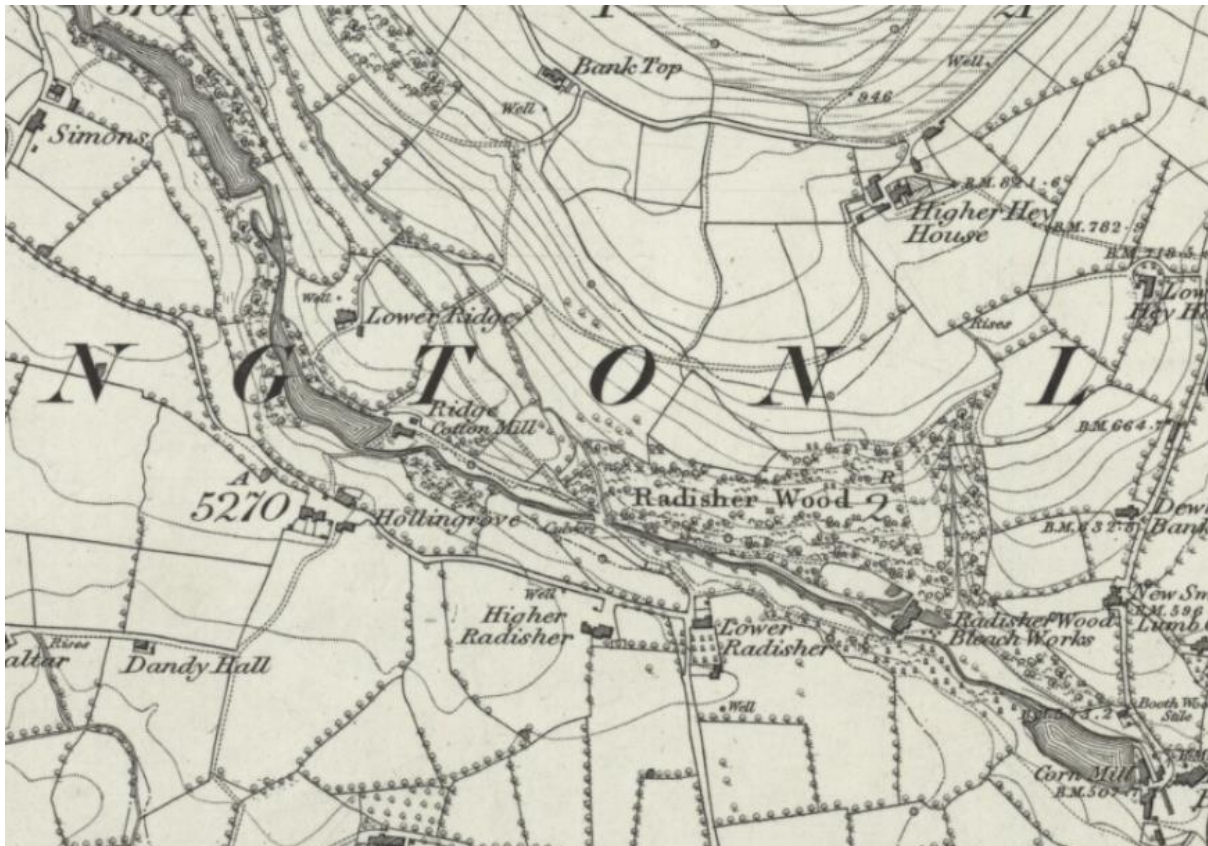
Figure 4: OS Six-inch England and Wales, Lancashire LXXIX (includes: Haslingden; Ramsbottom; Tottington; Turton), Surveyed: 1844 to 1847, Published: 1850. Copyright National Library of Scotland <https://maps.nls.uk/view/102344000>

The OS Six-inch England and Wales, Lancashire LXXIX published in 1859 (figure 4) is one of the earliest maps detailing Redisher (labelled 'Radisher') Wood and the larger survey area. Clearly depicted is the site of Radisher Bleach Works to the southeast of the woodland on the north bank of Holcombe Brooks. Further west, the site of Ridge Cotton Mill (powered by Holcombe Brook) is also depicted along with the site of an adjacent reservoir and one further up Holcombe Brook, located beyond the reach of this survey. With the exception of Radisher Wood, the landscape within the survey area is a mixture of irregular and more formal field enclosure.

The more formal pattern of enclosure centres on the steep south-facing slope to the west of Radisher Wood, with the irregular pattern located towards the foot of the valley. Central to the irregular pattern of enclosure is the site of Lower Ridge, which occupies the summit of the low ridge at the foot of the valley. The irregular pattern of enclosure is indicative of a medieval adhoc pattern of enclosure, whereas that upon the south-facing slope (which is in contrast to the pattern of enclosure on the more

Platforms recognised as Site No's 21 and 22 represent the site of Ridge Cotton Mill, a mill recorded as operational at the time of the OS Six-inch England and Wales, Lancashire LXXIX publication in 1850 (figure 4). Subsequent surveys record its gradual decline.

Situated at the summit of the low ridgeline located at the foot of the valley are the remains of the farmstead of Lower Ridge. The site is recorded on the 1850 OS Six-inch England and Wales, Lancashire (figure 4) and subsequent surveys. The main house is depicted as measuring 13.5m long (east-west) by 8.7m wide (north-south), and is divided into two parts. In addition, each division included two off-shoots extending to the north, each of which measured approximately 2.0m by 2.0m. There is also a building, detached, to the southeast measuring 9.5m x 6.5m. By the time of the 1910 Country Series Survey (figure 6) publication, an extension to the west of the main house had been added, measuring 8.0m in length and 2.0m in width. The building to the southeast had also developed with multiple divisions along with the introduction of two additional smaller buildings to the southwest of it. The 1930 Country Series Survey (figure 7), indicates the extension to main house had shortened, and widened and measures approx. 5.0m by 5.0m. In the 1938 County Survey series, main feature is extended to the east by approx. 3.50m and the extension to the southwest is extended by approx. 3m to the south. A semi-circular enclosure is then built to the east of the building and appears in the 1964 NG map. The archaeological survey recorded upstanding walls (1.50m high) to ground floor window level. Access to the farmstead was via a north-south orientated lane which provided access to Holcombe to the southeast via and brook. The site of the main house' garden is marked by rectangular sandstone flagstones set on edge; each measures approximately 0.10m x 1.0m x 1.0m.

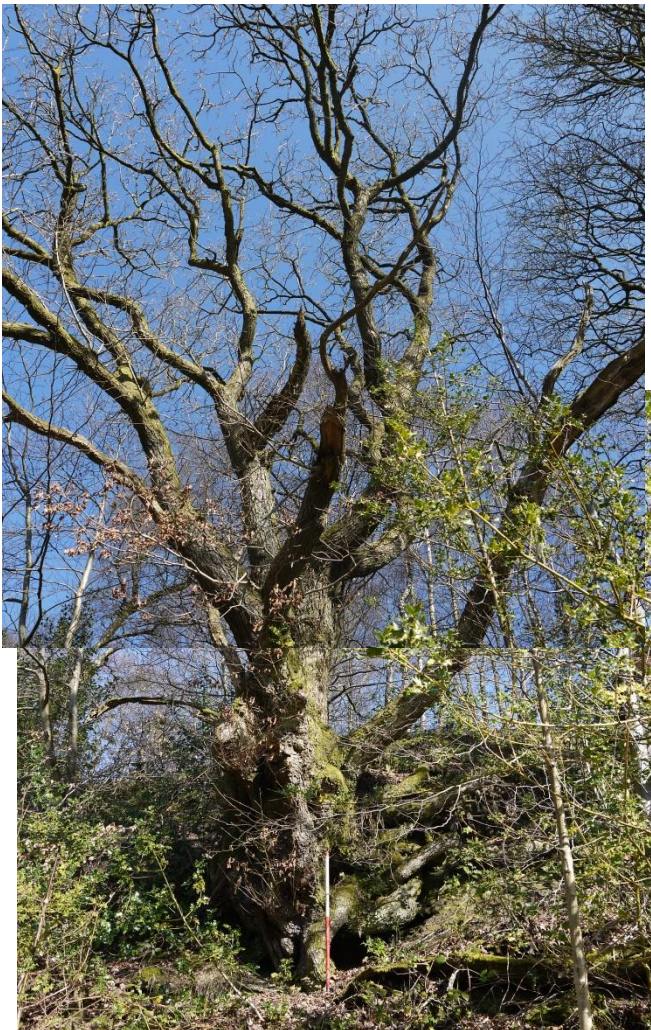
A veteran multi-stemmed oak (Site No. 22; plate 4) was recorded at NGR: 377136 415702, on the northern edge of the principle trackway that runs parallel to Holcombe Brook. The oak measures approximately 3.0m in circumference, with the largest of the projecting poles measuring 1.10m in circumference. The tree stands up to 15.0m tall. It appears the tree has been managed both as a coppice and pollard in the past, although wind damage or grazing may give this appearance.

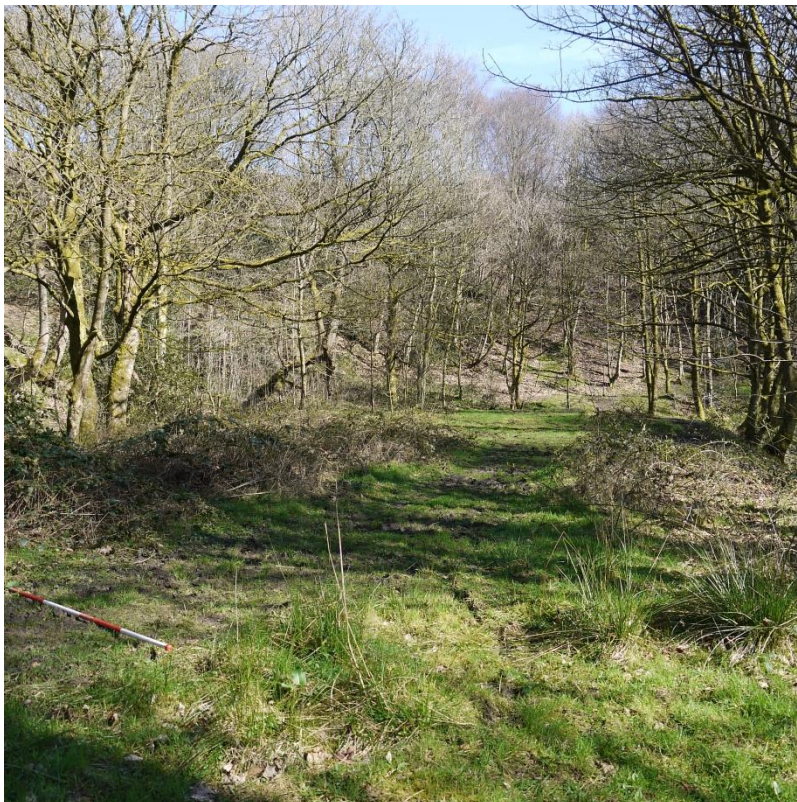
*Plate 5: Site of Ridge Cotton Mill (Site No. 21) (Scale is 2.0m; Photograph: P1040670). Copyright Pennine Prospects*

The site has been largely cleared; leaving a levelled platform to the east of the accompanying reservoir. Observations of the east end of the reservoir noted dressed gritstone masonry which along with marking the edge of the reservoir embankment, may also represent the foundations of the mill itself.

Although there are upstanding structural remains for a number of the surveyed farm/homestead sites as well as the mill sites, the survival of platforms also suggests a moderate to high degree of preservation concerning below ground archaeological features and deposits relating to each site. This is particularly important as many of the sites may have been established on medieval foundations. As such scrub and sapling tree vegetation should be monitored and where necessary reduced upon features to reduce the risk of disturbance to above and belowground archaeological features and deposits. Young and mature trees upon or within the immediate vicinity should be coppiced/pollarded or felled in order to prevent windthrow damage. Any works at the site will likely require archaeological intervention.

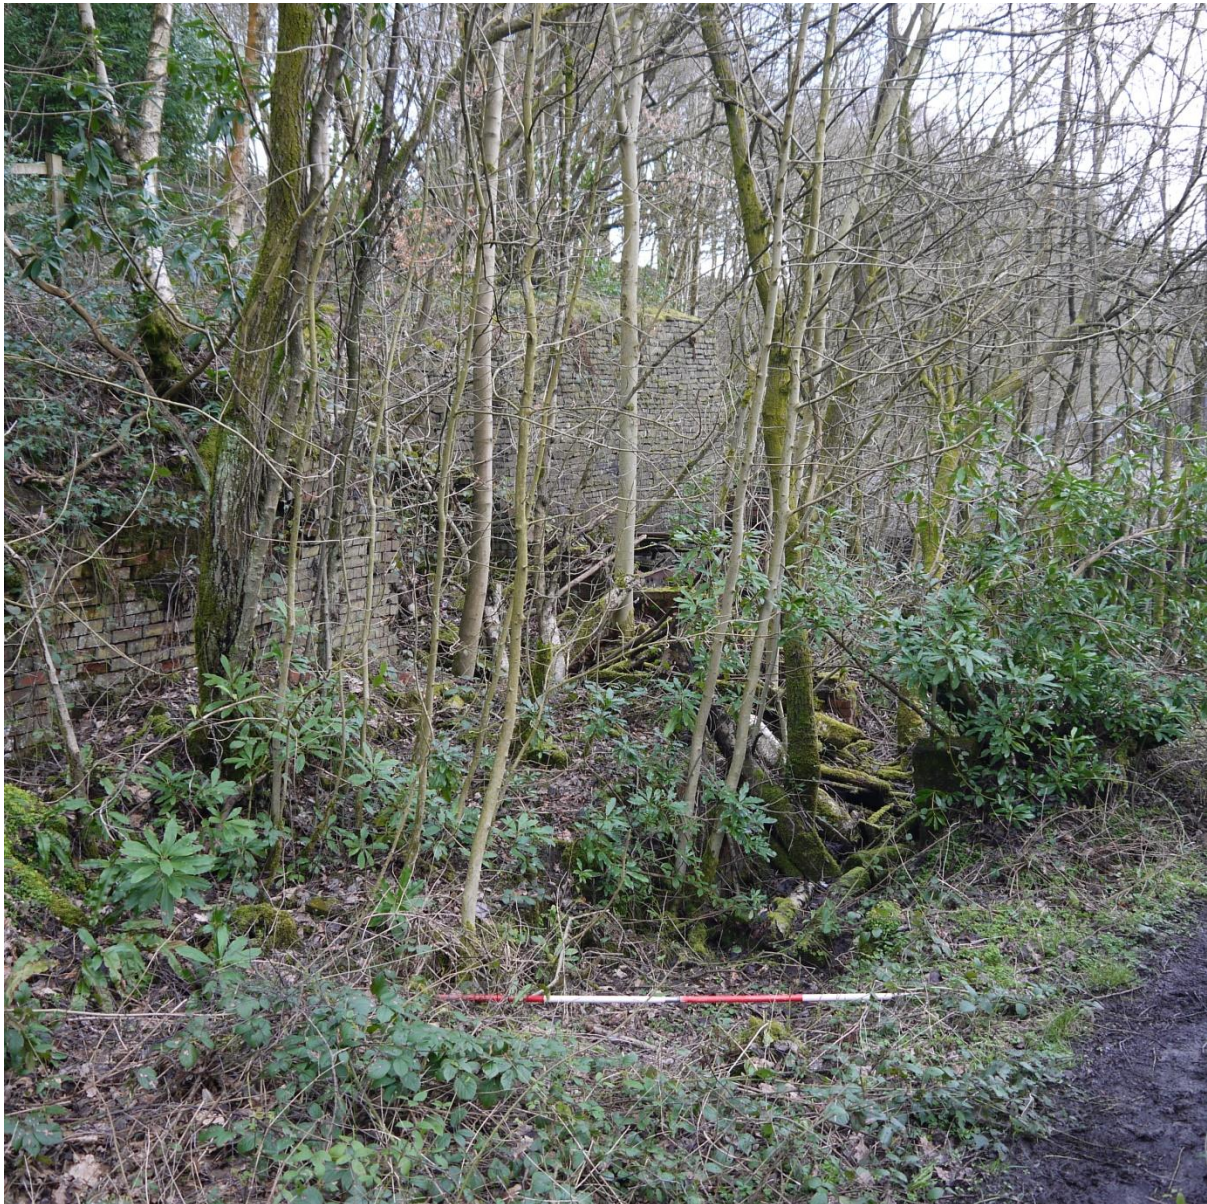
**Site No. 11 - Redisher Bleach and Dye Works**

*Plate 6: Structure relating to the Redisher Bleach and Dye works early 20th Century enlargements (Scale is 2.0m; Photograph P1040651). Copyright Pennine Prospects*

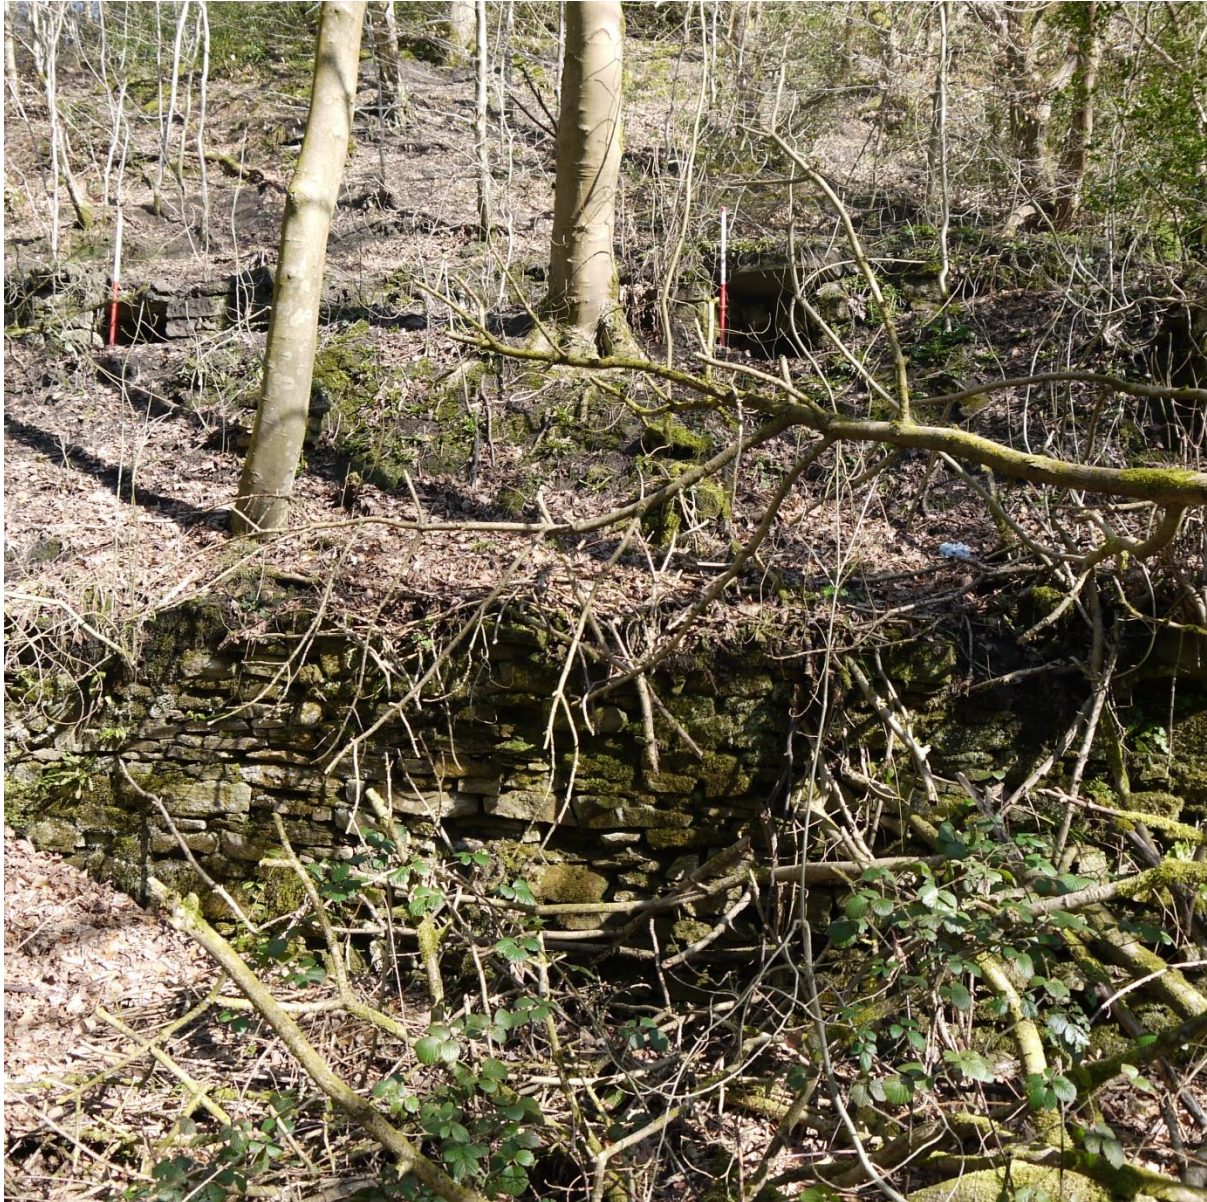
**Site No. 19 – Multi-roomed Structure**

*Plate 7: Overgrown site of a four-roomed structure on the south-facing bank of Holcombe Brook (Scales are 1.0m; Photograph: P1040666). Copyright Pennine Prospects*

offices and/or workers accommodation. Only the foundations of the structure are visible, the most substantial remains are those of the rear retaining wall which stands up to 2.0m high.

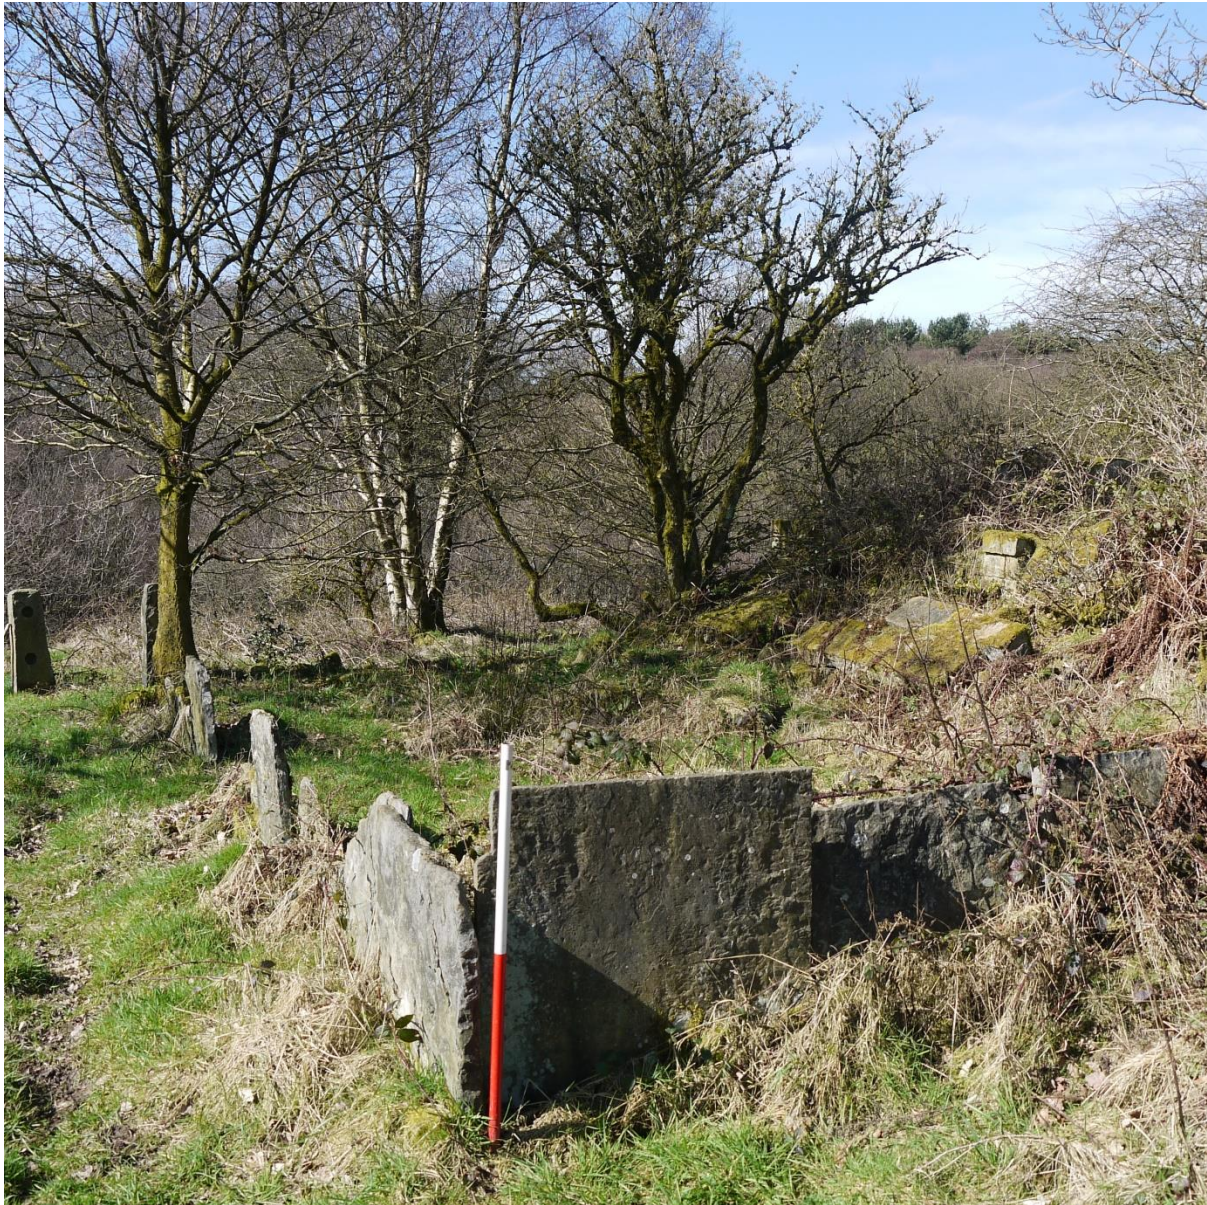
*Plate 8: The flagstone walled garden and overgrown site of Lower Ridge house (right) viewed from the southeast (Scale is 1.0m; Photograph: P1040678). Copyright Pennine Prospects*

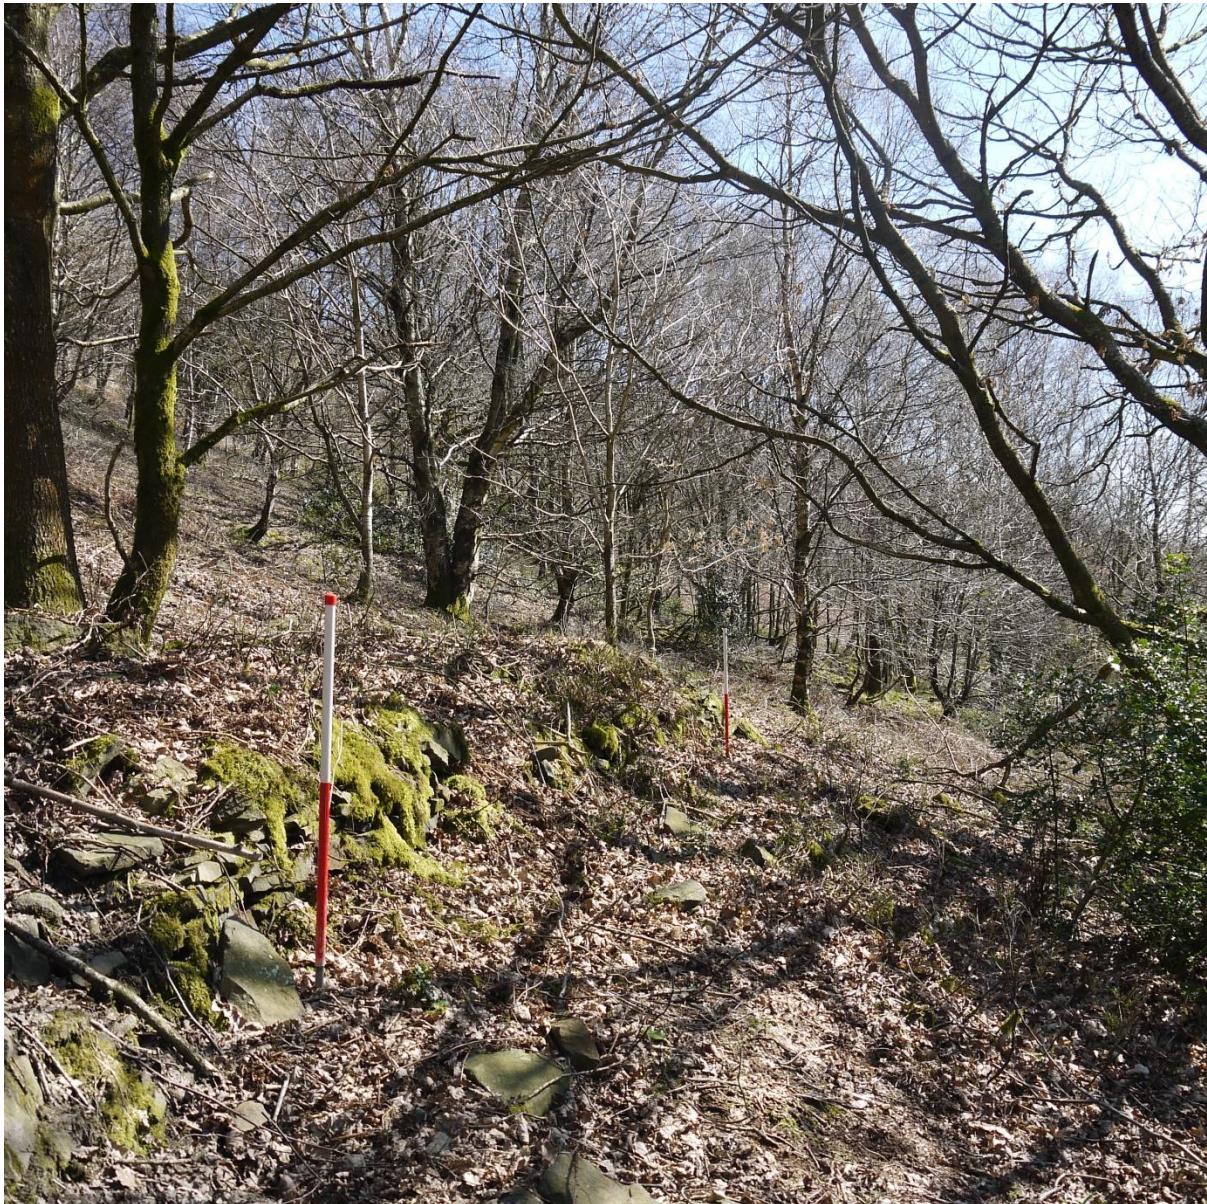
The following boundaries were recorded during the course of the survey: Site No. 5, 6, 18, 24, 29, 34, 35 (plate 9), 36, 37 and 39. They all appear on the 1893 First County Series Survey (figure 5). It is suspected that some of these may have had medieval origins which remained relevant and in use during the 19<sup>th</sup> century, as is evident from the available historic mapping. The majority of boundaries can be characterised as irregular drystone walls, although a number do incorporate orthostats. The boundaries stand up to 1.50m tall.

*Plate 9: Irregular Dry Stone Wall (Site No. 35) traversing the south-facing slope (Scale is 1.0m; Photograph: P1040697). Copyright Pennine Prospects*

All of the boundaries recorded during the survey are either relict or in numerous states of decline. Each boundary should be monitored to ensure ground vegetation and tree saplings do not establish themselves on the stonework and cause damage/erosion. Mature trees within close proximity of all of the boundaries recorded during the survey should also be monitored and where appropriate, coppiced/pollarded, crowned, thinned or removed to prevent windthrow damage to the features. Although relict, the boundaries should be stabilised where necessary and maintained as relict features.

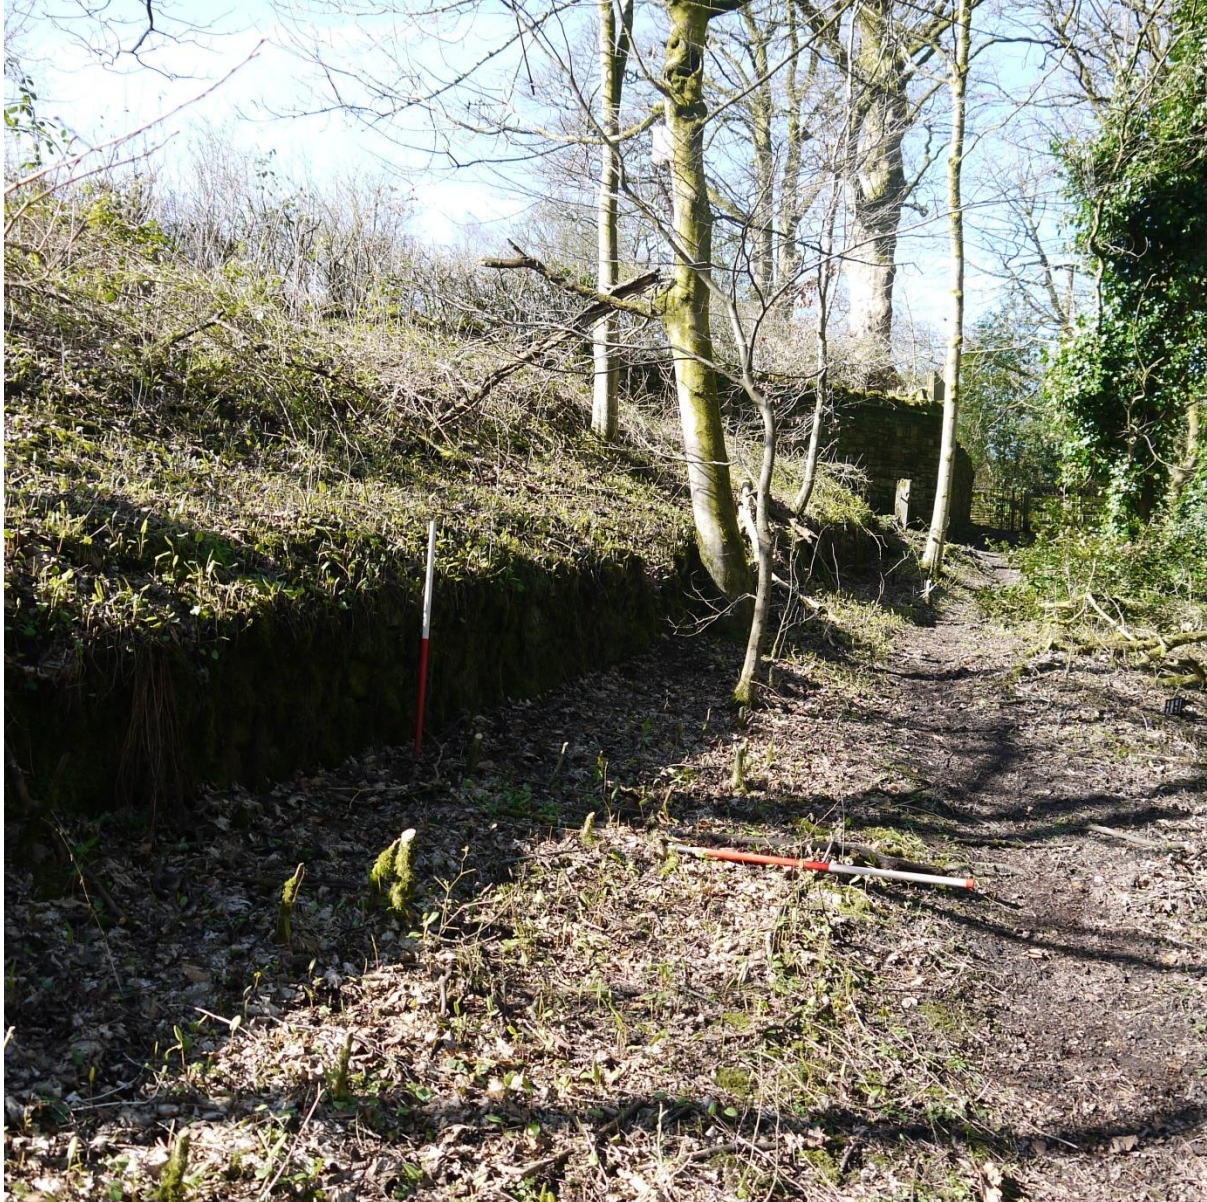
which traverses the south-facing slope, providing access to an area of mineral extraction (Site No. 8) and to the east connects with Redisher Bleach and Dye Works and Holcombe beyond.

*Plate 10: Primary trackway/carriageway (Site No. 15) which serves to connect the farm of Lower Ridge with the bleach and dye works and Holcombe (Scales are 1.0m; Photograph: P1040658). Copyright Pennine Prospects*

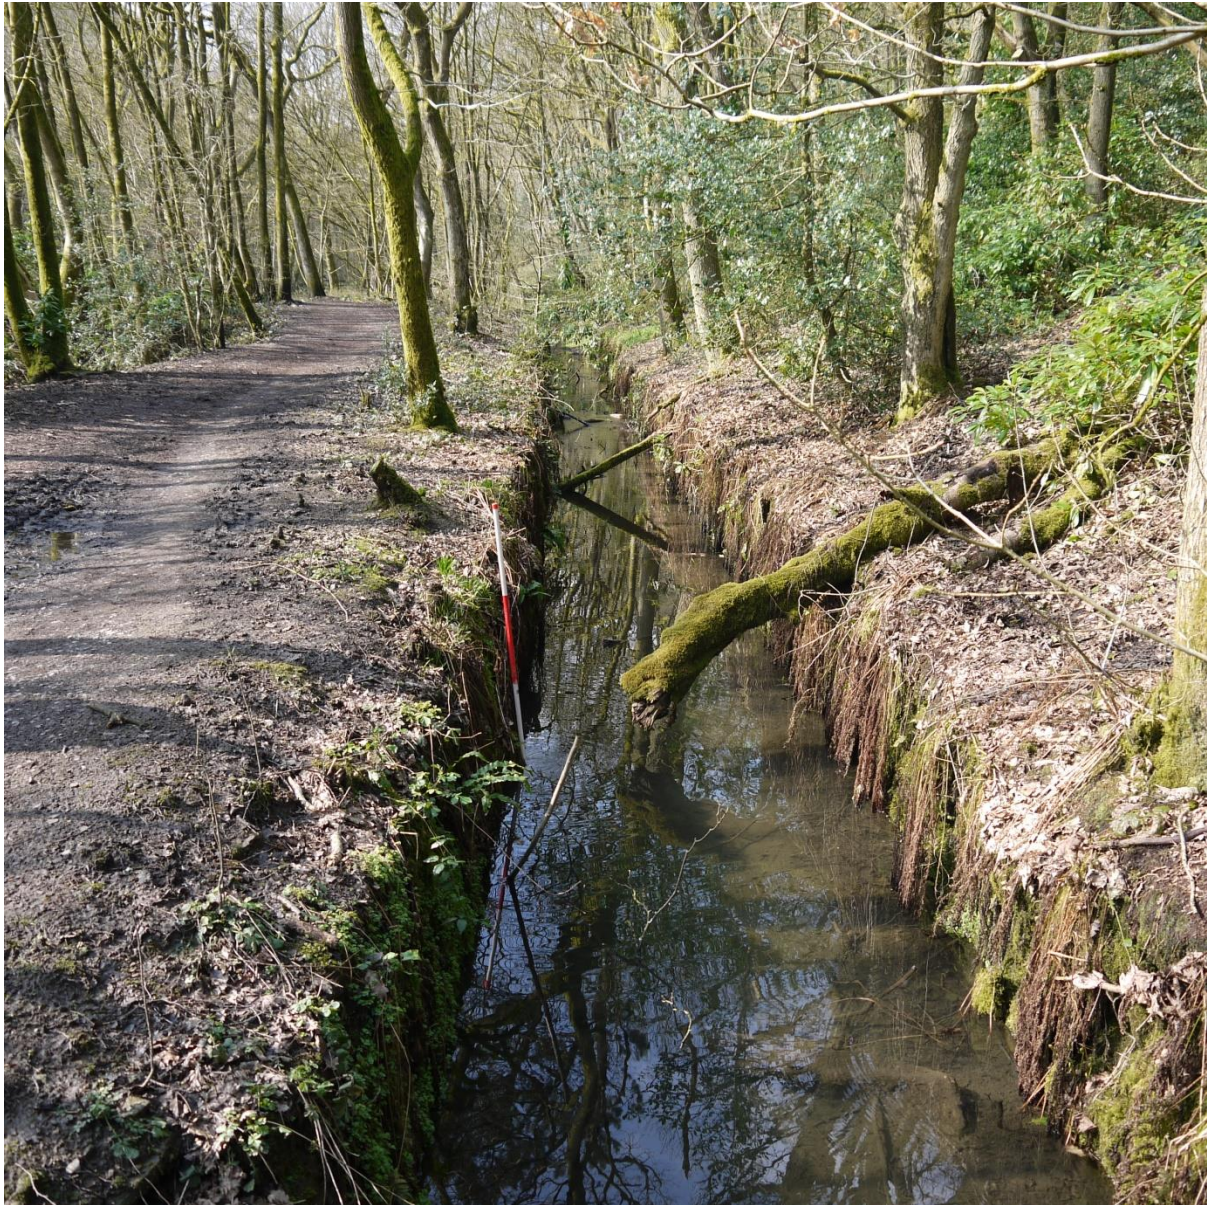
Two reservoirs (Site No. 12 and 13) and one leat/goit (Site No. 14; plate 11) were recorded during this survey. Both reservoirs are noted on the 1893 First County Series Survey and supported the Redisher Bleach and Dye Works located immediately to the east. Both are small with the larger of the two (Site No. 13) measuring 30.0m east-west, 15.0m north-south and up to 3.0m deep. The leat/goit is orientated east-west and served to supply the reservoirs located at Redisher Bleach

and Dye Works from Holcombe Brook. The watercourse measures c.2.0m wide and up to 1.50m deep.

*Plate 11: Leat/Goit (Site No. 14) viewed from the east (Scale is 2.0m; Photograph: P1040653).  
Copyright Pennine Prospects*

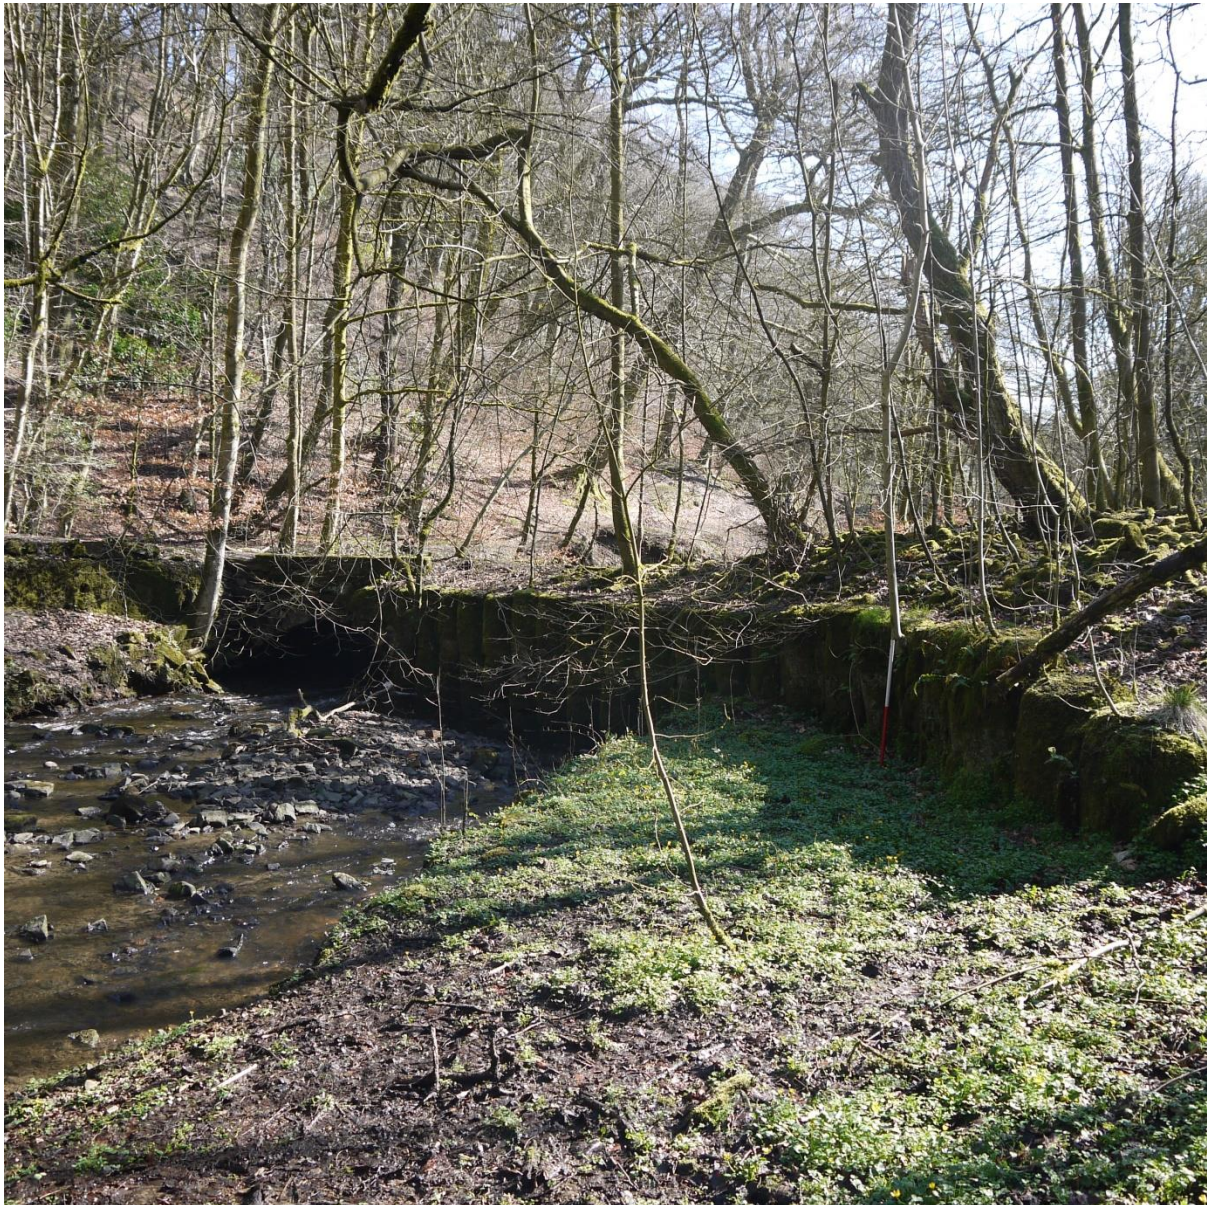
Revetment boundary Site No.17 (Plate 12) first appears on the 1964 National Grid Map. The revetment wall forms the eastern edge of Holcombe Brook on its approach to a bridge to the east. The feature, constructed of upright cylindrical concrete columns may make use of Second World War road obstacles using (although it should be noted that the obstacles are not a standard military pattern).

*Plate 12: Revetment boundary (Site No. 18) constructed of concrete columns (Scale is 1.0m; Photograph: P1040663). Copyright Pennine Prospects*
